REPORT BMS68

Performance Test of
Floor Coverings for Use in
Low-Cost Housing: Part 3

PERCY A. SIGLER
and ELMER A. KOERNER

NATIONAL
BUREAU OF STANDARDS

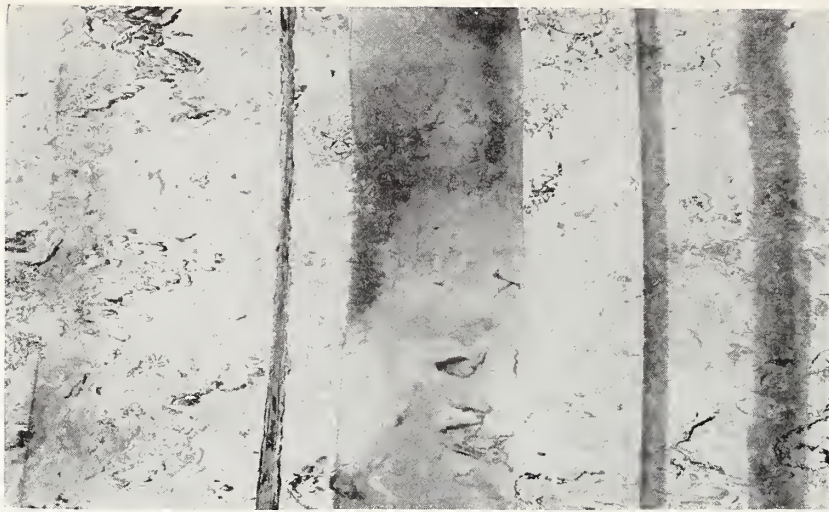
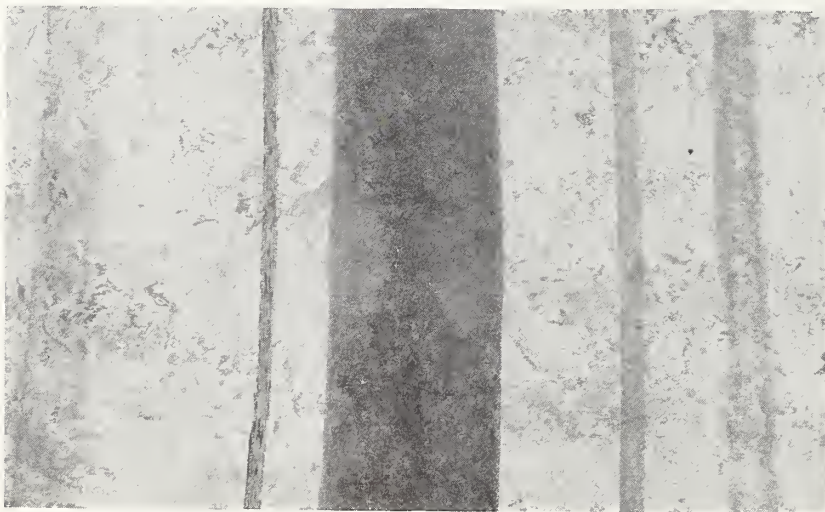
The ¼-in. marbleized linoleums, panels 1L, 2L, 1R, and 2R, showed very good performance, with the possible exception of panel 2L (see figs. 3, 4, 5, and 6). In panel 2L a dry lining felt was used over the strip-wood subfloor. The action of the steel-tired truck wheel caused the dry lining felt to laminate, resulting in an appreciable fracture of the linoleum (see figure 4). In panel 2R, where an asphalt-saturated

FIGURE 3.— $\frac{1}{8}$ -in. marbled linoleum on concrete subfloor (test panel 1L).

FIGURE 5.— $\frac{1}{8}$ -in. marbled linoleum on concrete subfloor (test panel 1R).

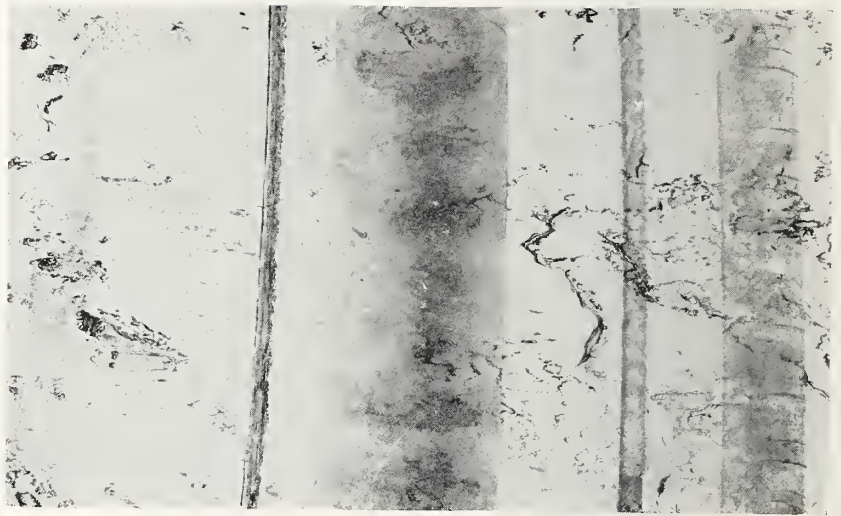
FIGURE 4.— $\frac{1}{8}$ -in. marbled linoleum on strip-wood subfloor (test panel 2L).

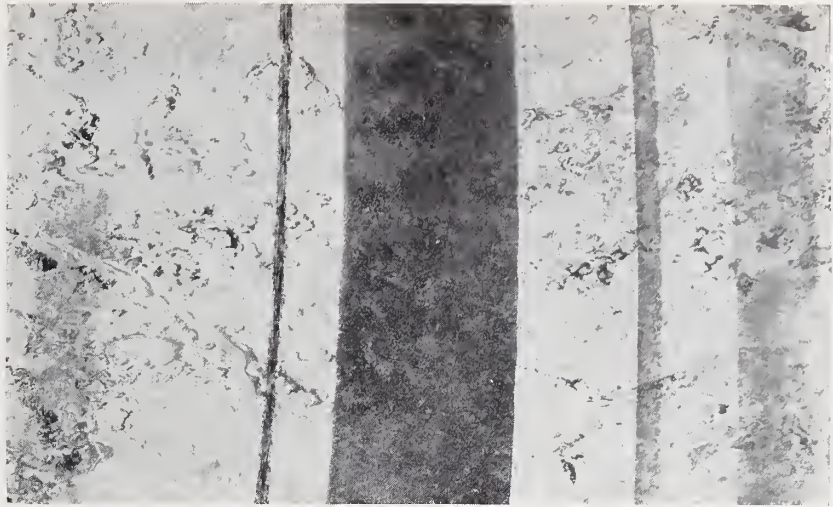
lining felt was used, there was no evidence of separation in the felt and the steel-tired truck wheel caused only slight fracture of the linoleum (see figure 6). The tan marbleized linoleum showed better resistance to abrasion than the white marbleized linoleum (see table 2).

FIGURE 6.— $\frac{1}{8}$ -in. marbled linoleum on strip-wood subfloor (test panel 2R).

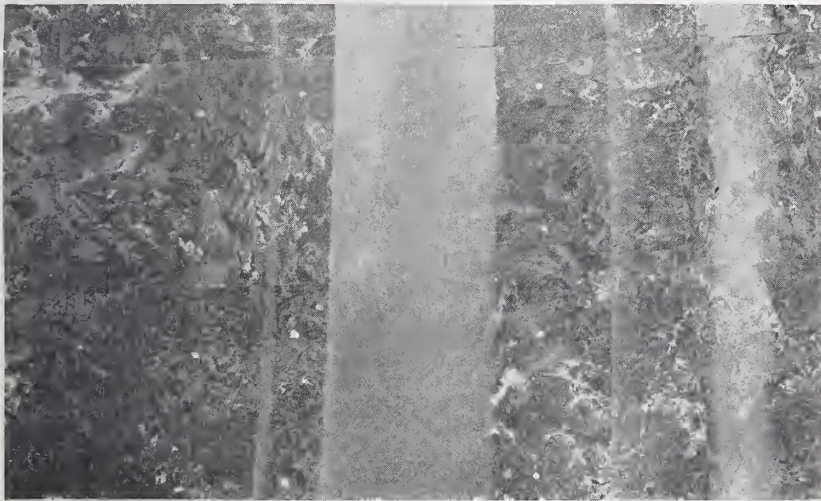
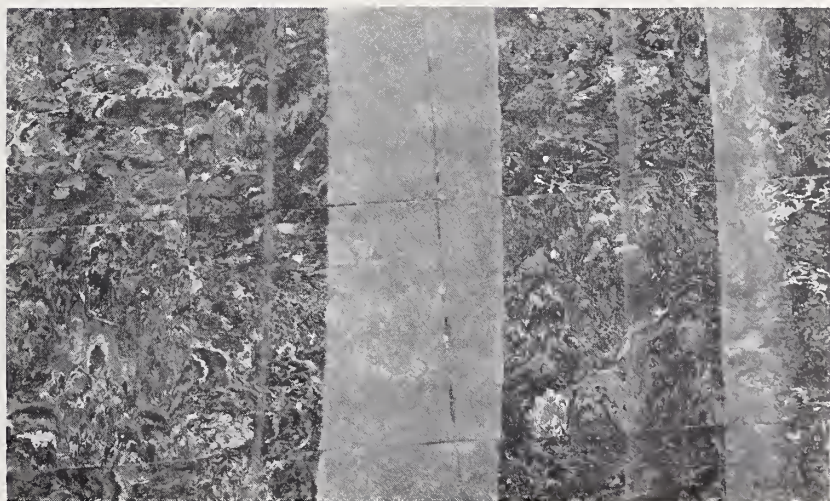
The 1/8-in. linoleum tile, panels 3R and 4R, gave very good performance, particularly with reference to abrasion (see figs. 7 and 8). On a concrete subfloor the tiles were fractured slightly by the steel-tired truck wheel.

FIGURE 7.— $\frac{1}{8}$ -in. linoleum tile on concrete subfloor (test panel 3R).

FIGURE 8.— $\frac{1}{8}$ -in. linoleum tile on strip-wood subfloor (test panel 4R).

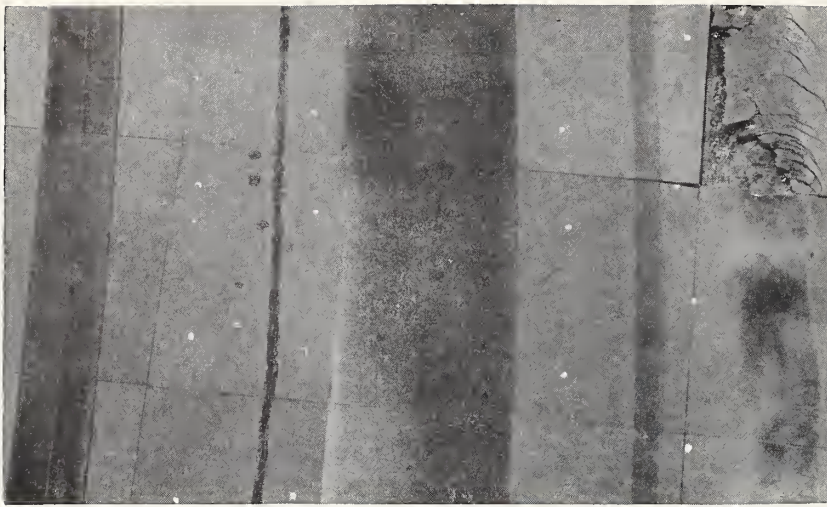
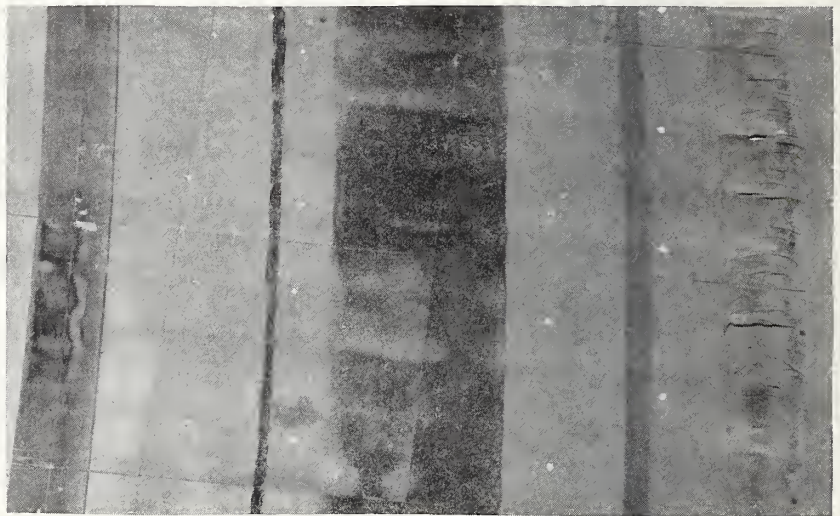
The 1/8-in. cork-composition tile, panels 3L and 4L, showed good performance except under the action of the steel-tired truck wheel, which fractured the tiles considerably (see figs. 9 and 10). On a concrete subfloor, panel 3L, tiles along the path of the steel-tired truck wheel showed failure in bond and were fractured at an early stage of the test. They were replaced with new tiles at 1,240 cycles, which proved to be equally unsatisfactory. The tiles showed good resistance to abrasion.

FIGURE 9.— $\frac{1}{8}$ -in. cork-composition tile on concrete subfloor (test panel 3L).

FIGURE 10.— $\frac{1}{8}$ -in. cork-composition tile on strip-wood subfloor (test panel 4L).

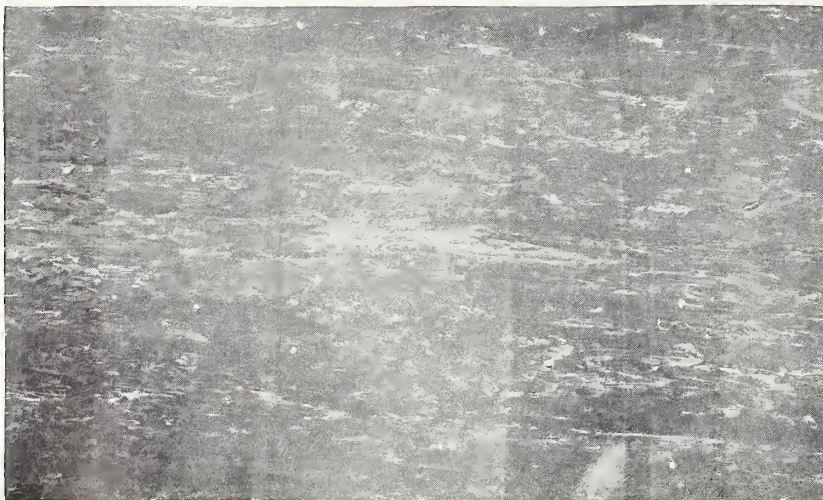
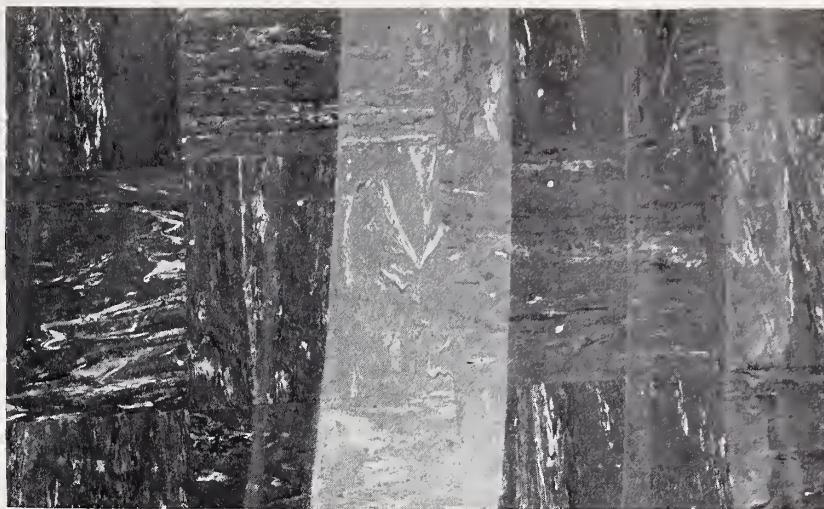
ance test [3]. These floor coverings on a concrete subfloor, panels 5L and 5R, gave very good performance. Along the path of the steel-tired truck wheel there were small welts in the floor coverings, caused by accumulations of the adhesives (see figs. 11 and 12). The sheet rubber showed slightly better resistance to abrasion than the rubber tile (see table 2 in this report and table 2 in report BMS43).

FIGURE 11.— $\frac{1}{8}$ -in. sheet rubber on concrete subfloor (test panel 5L).

FIGURE 12.— $\frac{1}{8}$ -in. rubber tile
on concrete subfloor (test panel
5R).

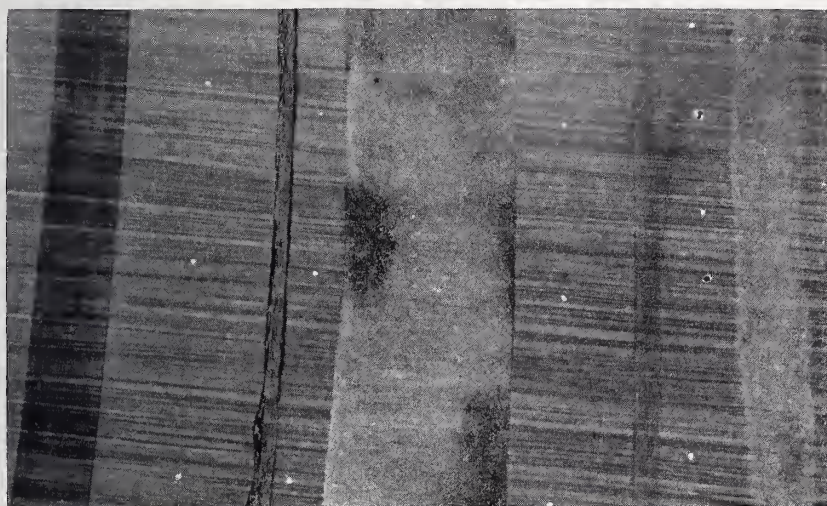
The jaspe linoleum, panel 6L, was an additional portion of a sample used in a previous performance test [2]. In the previous test, extensive failures in adhesion to the subfloors occurred at an early stage of the test and the linoleum was in unserviceable condition at the end of the test. In the present test, with a different adhesive, there was no evidence of failure in bond and the floor covering showed good performance (see fig. 13).

FIGURE 13.— $\frac{3}{32}$ -in. jasper lin-
oleum on concrete subfloor
(test panel 6L).

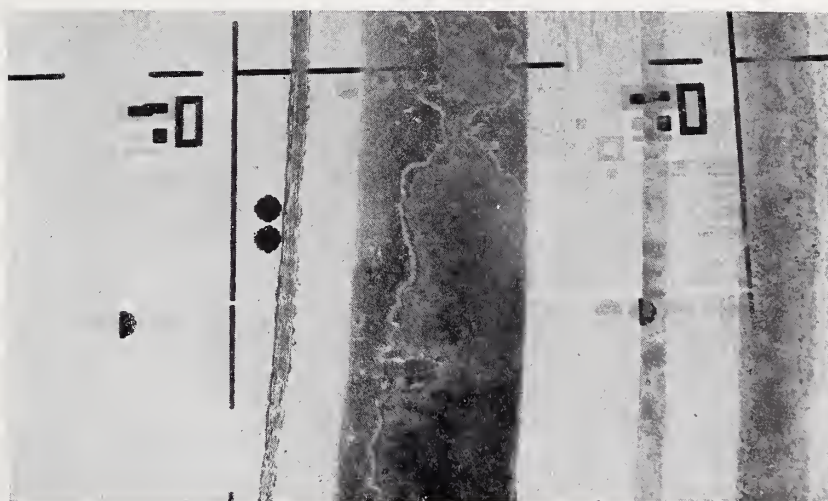
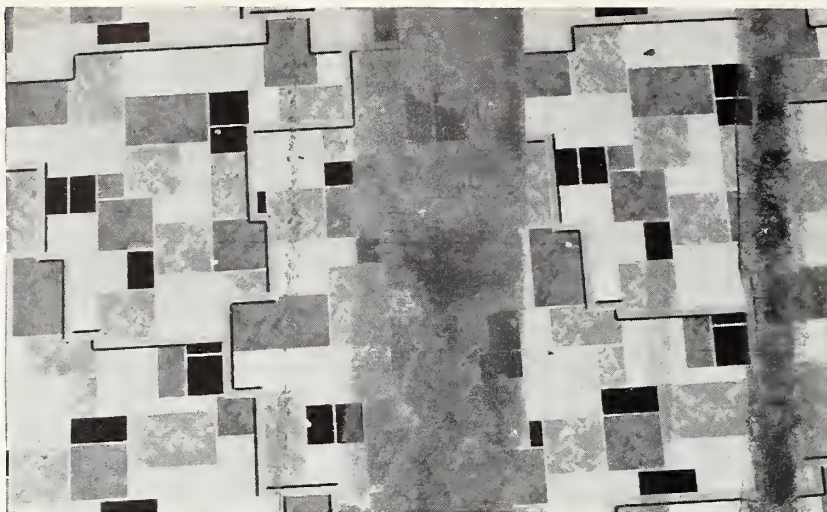
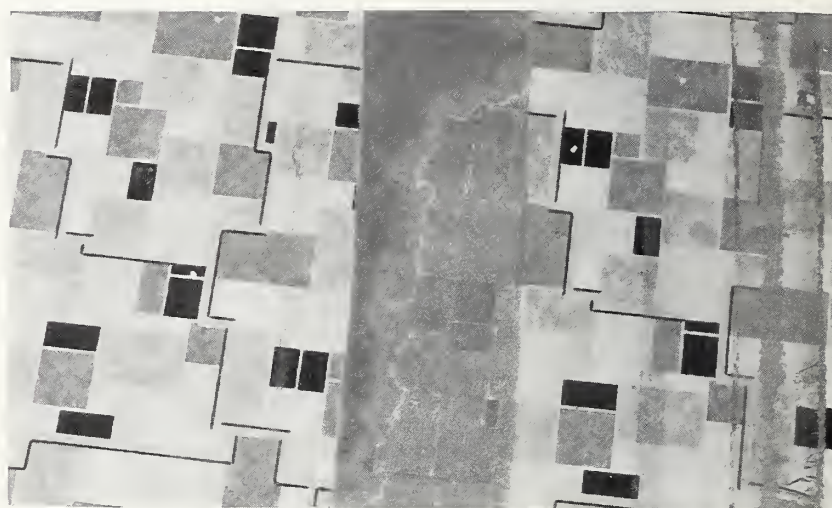
The felt-base floor coverings with a wearing surface of enamel, panels 6R, 7R, and 8L, gave fair performance considering the type of service for which they are designed. The floor coverings were in unserviceable condition at the end of the test (see figs. 14, 15, and 16). On a Douglas fir plywood subfloor, panel 8L, the steel-tired truck wheel caused considerable depression and fracture in the floor covering (see table 1 and fig. 16); otherwise the floor covering presented a more even surface than is usually obtained on a strip-wood subfloor. The enamel surfaces of the floor coverings were worn through in spots by the walking wheel in approximately 30,000 cycles, or 6,000 cycles after the wheel had been covered with abrasive cloth. The total depth of wear is shown in table 2.

FIGURE 14.— $\frac{5}{64}$ -in. felt base,
enamel wearing surface, on
concrete subfloor (test panel
6R).

FIGURE 15.— $\frac{5}{64}$ -in. felt base,
enamel wearing surface, on
concrete subfloor (test panel
7R).

FIGURE 16.— $\frac{5}{64}$ -in. felt base,
enamel wearing surface, on
plywood subfloor (test panel
8L).

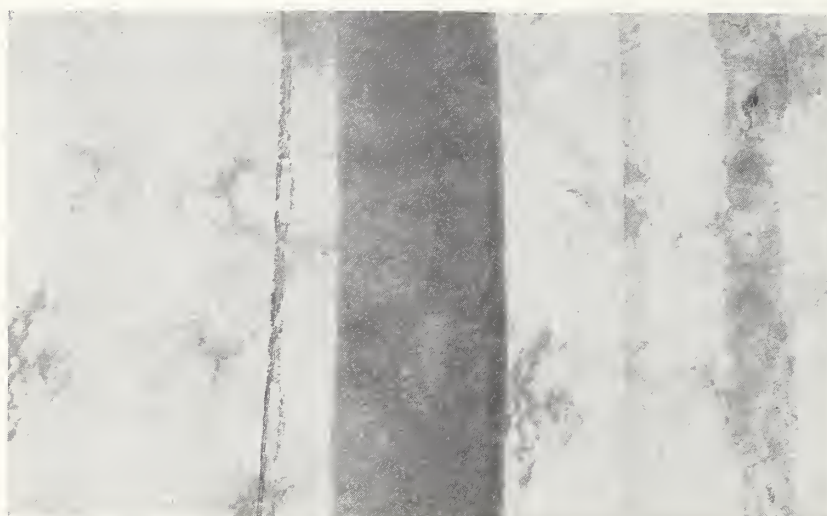
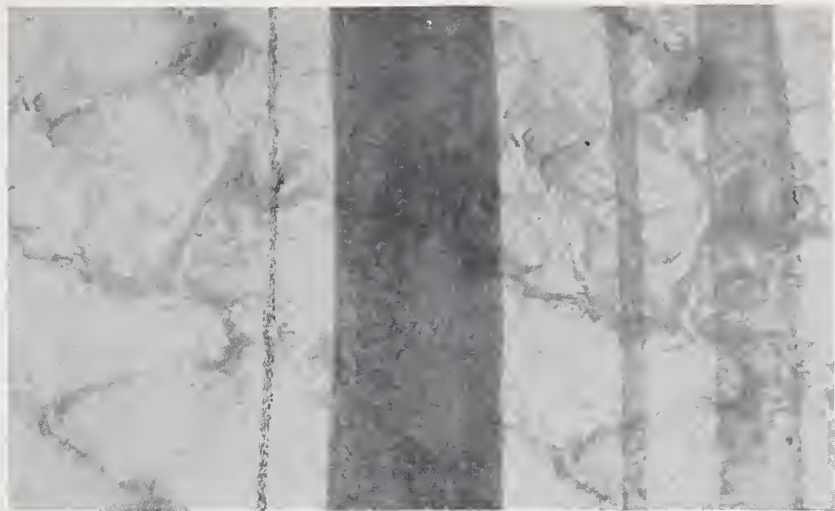
The felt-base floor covering with a wearing surface consisting of a resin-treated cotton-linters sheet, panels 7L and 8R, withstood the test very well. Along the path of the steel-tired truck wheel there was some failure in adhesion to the concrete subfloor and slight fracture of the floor covering (see fig. 17). On a Douglas fir plywood subfloor, panel 8R, the steel-tired truck wheel caused appreciable depression and slight fracture in the floor covering (see table 1 and fig. 18). The wearing surface showed good resistance to abrasion.

FIGURE 17.— $\frac{5}{64}$ -in. felt base,
resin treated cotton linters
sheet wearing surface, on
concrete subfloor (test panel
7L).

FIGURE 18.— $\frac{5}{64}$ -in. felt base, resin treated cotton linters sheet wearing surface, on plywood subfloor (test panel 8R).

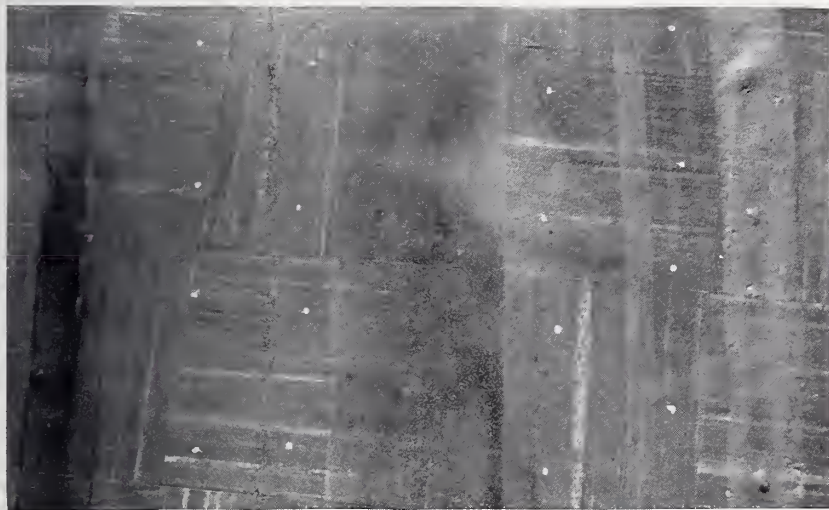
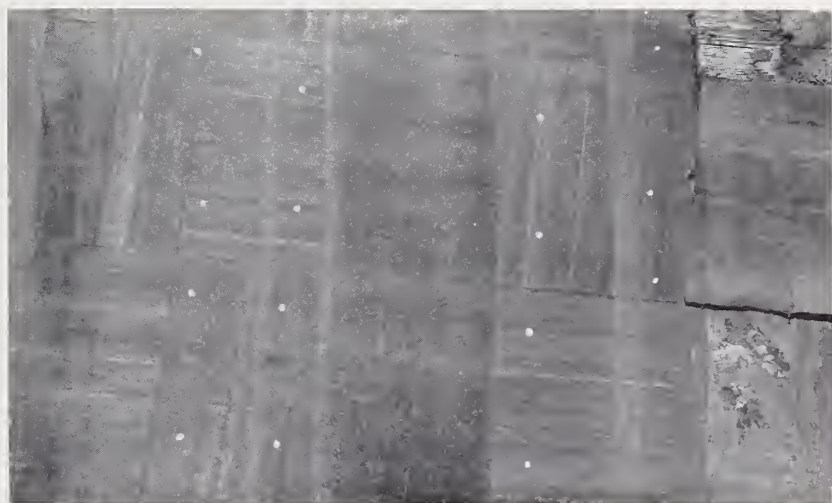
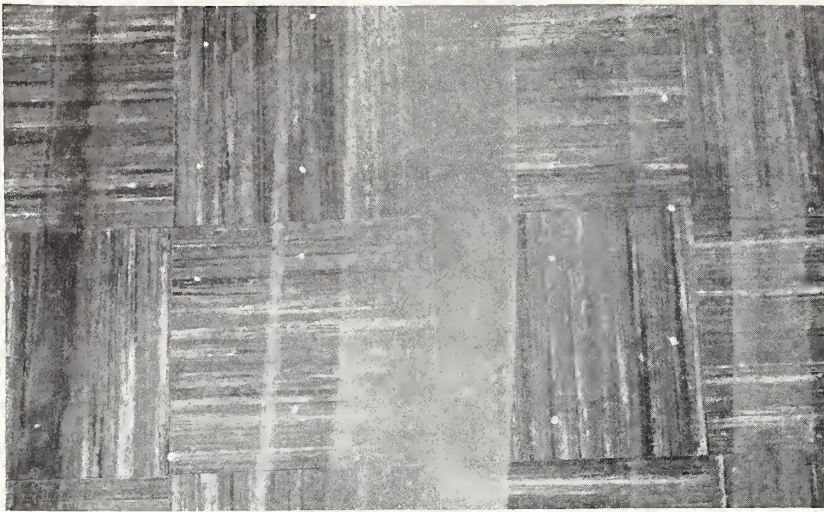
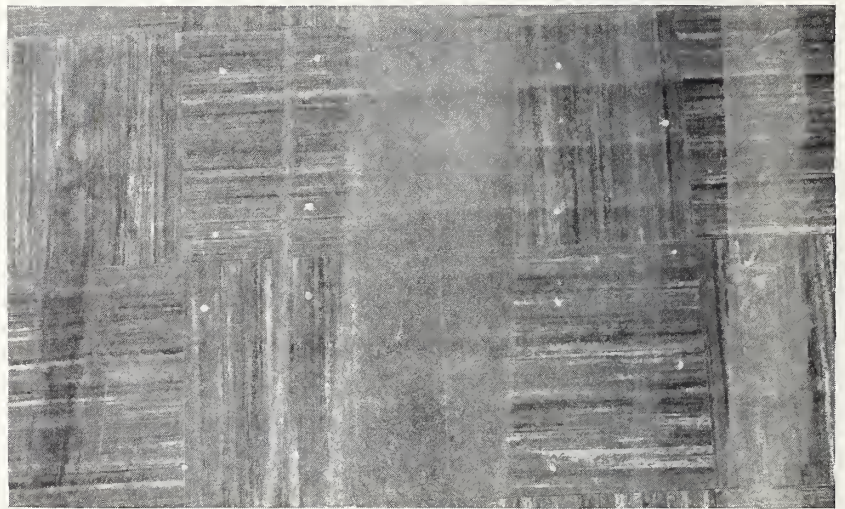
The 5/64-in. and the 7/64-in. felt-base tiles with a wearing surface consisting of a cellulose nitrate composition, panels 9L, 10L, 9R, and 10R,

FIGURE 19.— $\frac{5}{64}$ -in. felt-base tile, cellulose nitrate composition wearing surface, on concrete subfloor (test panel 9L).

FIGURE 20.— $\frac{5}{64}$ -in. felt-base tile, cellulose nitrate composition wearing surface, on strip-wood subfloor (test panel 10L).

FIGURE 21.— $\frac{7}{16}$ -in. felt-base tile, cellulose nitrate composition wearing surface, on concrete subfloor (test panel 9R).

FIGURE 22.— $\frac{7}{16}$ -in. felt-base tile, cellulose nitrate composition wearing surface, on strip-wood subfloor (test panel 10R).

withstood the test very well, with the possible exception of panel 10L (see figs. 19, 20, 21, and 22). On a strip-wood subfloor with a dry lining felt, panel 10L, the steel-tired truck wheel caused separation in the lining felt and displaced some of the tiles (see fig. 20). On a strip-wood subfloor with no lining felt, panel 10R, the $\frac{3}{4}$ -in. tiles were moderately fractured by the steel-tired truck wheel (see fig. 22). Ridges caused by the strip-wood subfloor showed on the surface of the $\frac{3}{4}$ -in. tiles with no underlay whereas they did not show on the surface of the $\frac{3}{4}$ -in. tiles with a felt underlay (compare figs. 20 and 22). The wearing surface of the tiles showed good resistance to abrasion.

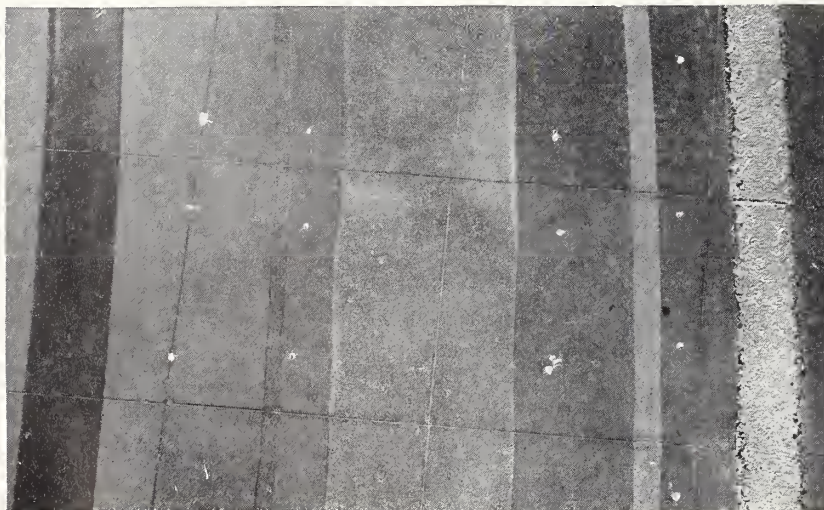
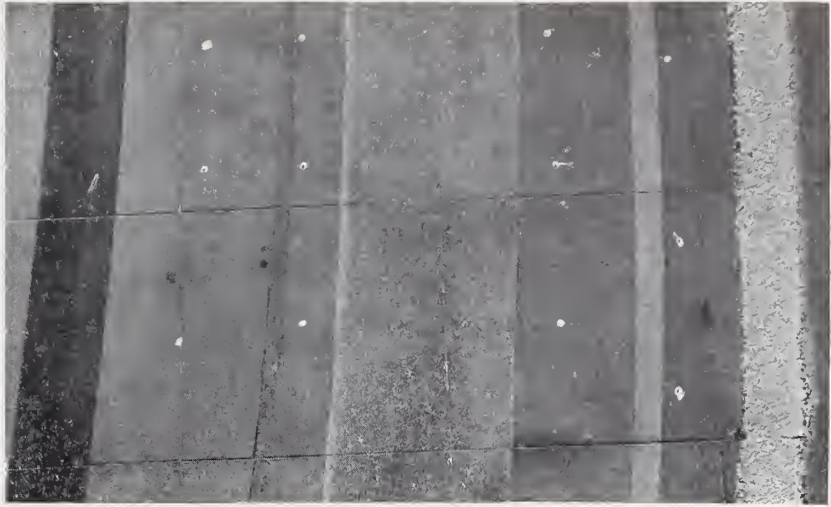
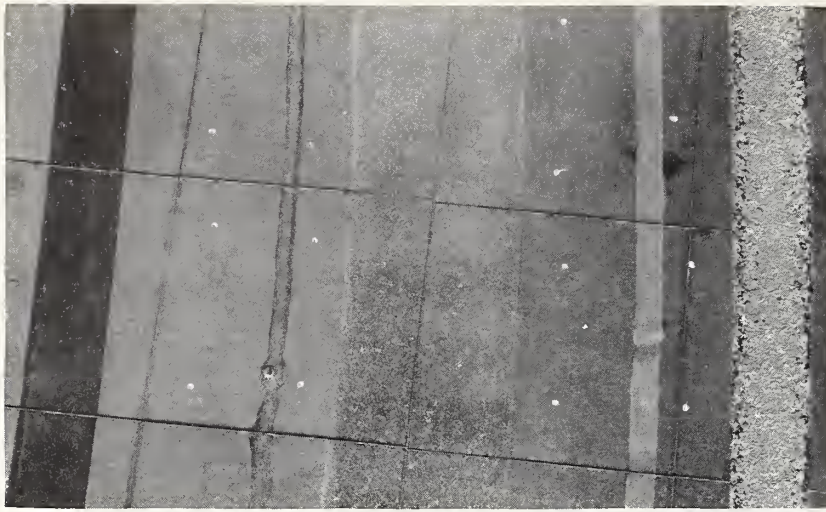
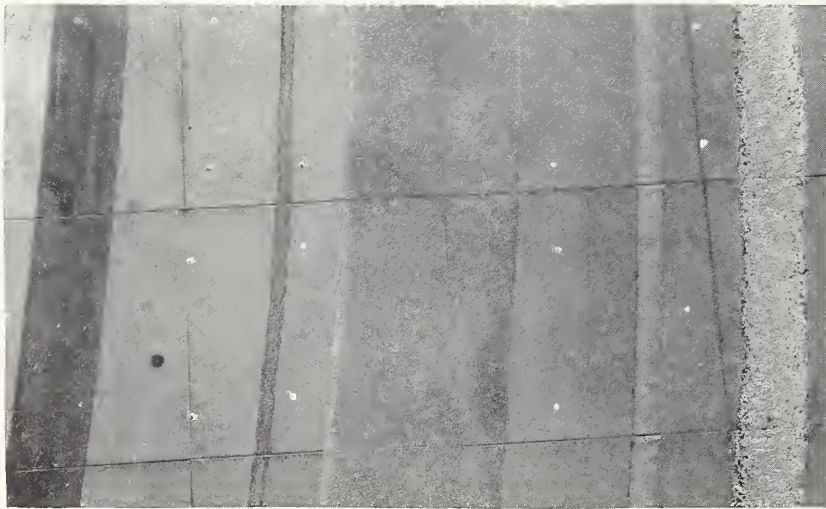
FIGURE 23.— $\frac{1}{8}$ -in. asphalt tile on concrete subfloor (test panel 11L).

FIGURE 24.— $\frac{1}{8}$ -in. asphalt tile
on concrete subfloor (test
panel 11R).

FIGURE 27.— $\frac{3}{16}$ -in. asphalt tile
on concrete subfloor (test panel
13L).

FIGURE 29.— $\frac{3}{16}$ -in. asphalt tile
on concrete subfloor (test panel
13R).

The $\frac{1}{8}$ -in. and the $\frac{3}{16}$ -in. asphalt tiles showed fair performance on a concrete subfloor (see figs. 23, 24, 27, and 29). They were pitted and worn to a moderate degree by the steel-tired truck wheel (see table 1). The $\frac{1}{8}$ -in. asphalt tiles on Douglas fir plywood subfloors with no underlay, panels 12L and 12R, showed fair performance except under the action of the steel-tired truck wheel, which crushed the tiles completely (see figs. 25 and 26). The $\frac{3}{16}$ -in. asphalt tiles on a strip-wood subfloor with an underlay of felt, panels 14L and 14R, did not stand up well in this test. The tiles were crushed by the steel-tired truck wheel and were fractured to an appreciable degree by the walking wheel (see figs. 28 and 30). In general, the asphalt tiles were worn to a moderate degree by the abrasive action of the walking wheel (see table 2).

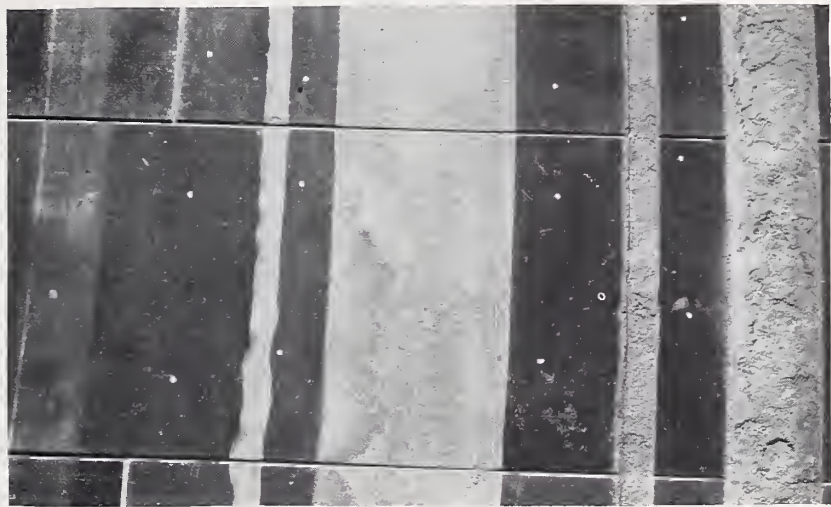
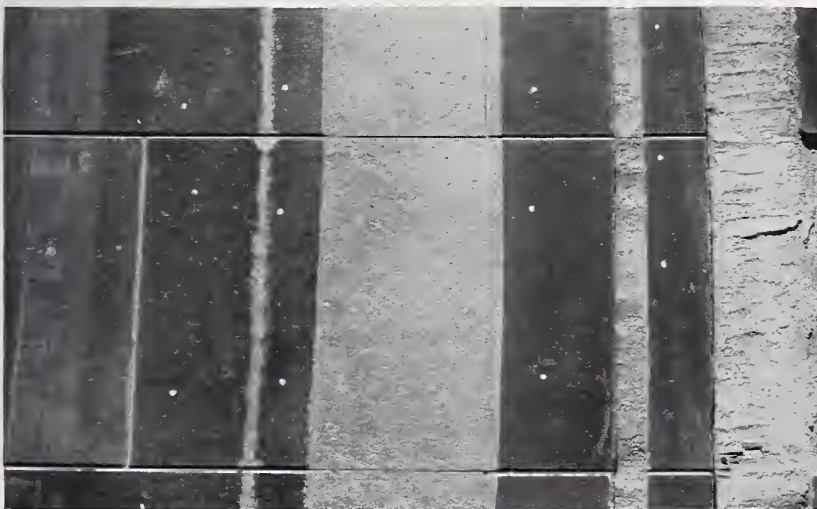
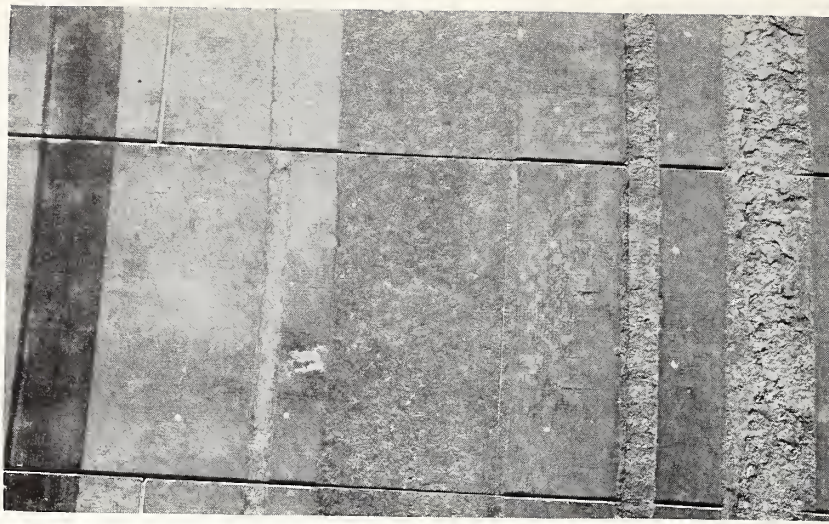
FIGURE 31.— $\frac{1}{4}$ -in. asphalt-
impregnated fiberboard tile on
concrete subfloor (test panel
15L).

FIGURE 32.— $\frac{1}{4}$ -in. asphalt-
impregnated fiberboard tile on
plywood subfloor (test panel
16R).

FIGURE 33.— $\frac{1}{4}$ -in. asphalt-impregnated fiberboard tile on concrete subfloor (test panel 15R).

The $\frac{1}{4}$ -in. asphalt-impregnated fiberboard tiles, panels 15L, 16R, and 15R, were in unserviceable condition at the end of the performance test. They were pitted and worn to a considerable degree by both the steel-tired truck wheel and the steel-wheel caster (see table 1 and figs. 31, 32, and 33). The painted surface of the tiles was worn through by the walking wheel in approximately 30,000 cycles, or 6,000 cycles after the application of the abrasive cloth. The total depth of wear is shown in table 2.

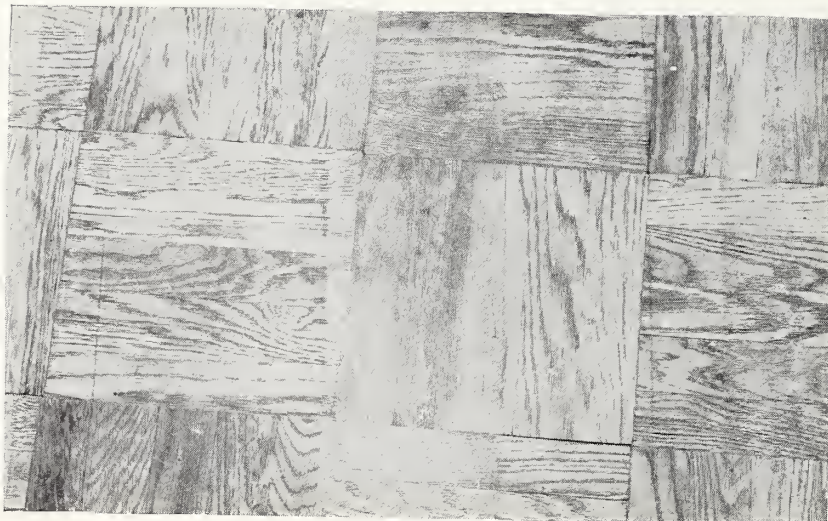
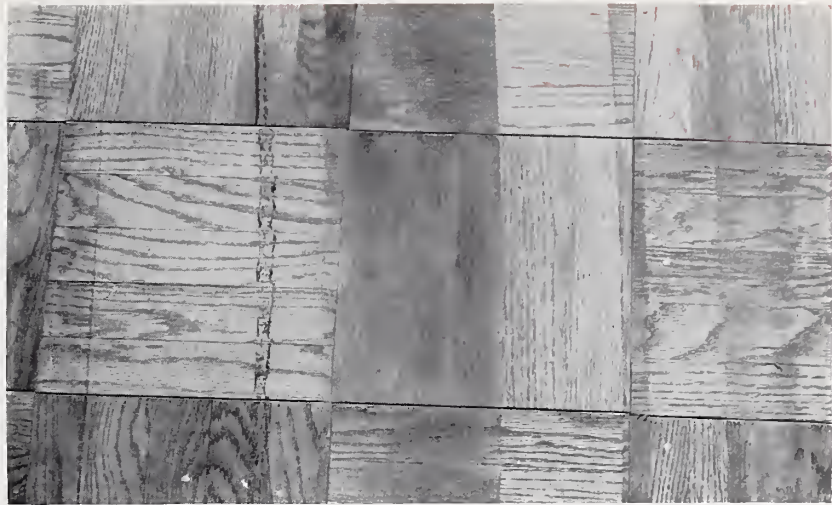
FIGURE 35.— $\frac{1}{2}$ -in. white-oak unit-block on concrete subfloor (test panel 17L).

FIGURE 36.— $\frac{1}{2}$ -in. red-oak unit-block on strip-wood subfloor (test panel 18L).

The white-oak and the red-oak unit-blocks, panels 17L and 18L, showed good performance. The unit-blocks were moderately compressed, and were fractured or splintered to a slight extent, by the steel-tired truck wheel (see table 1 and figs. 35 and 36). There was no evidence of failure in bond to the subfloors, although the individual strips in the unit-blocks showed a slight tendency to warp. The white-oak unit-blocks showed slightly better resistance to abrasion than the red-oak unit-blocks (see table 2).

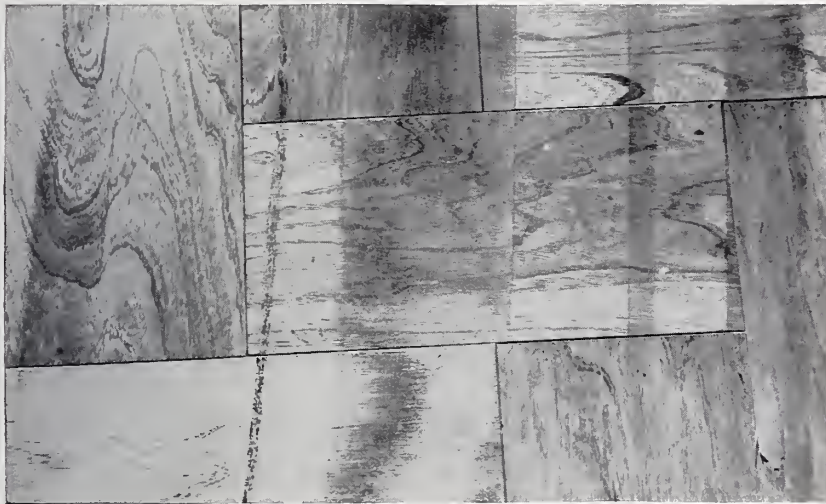
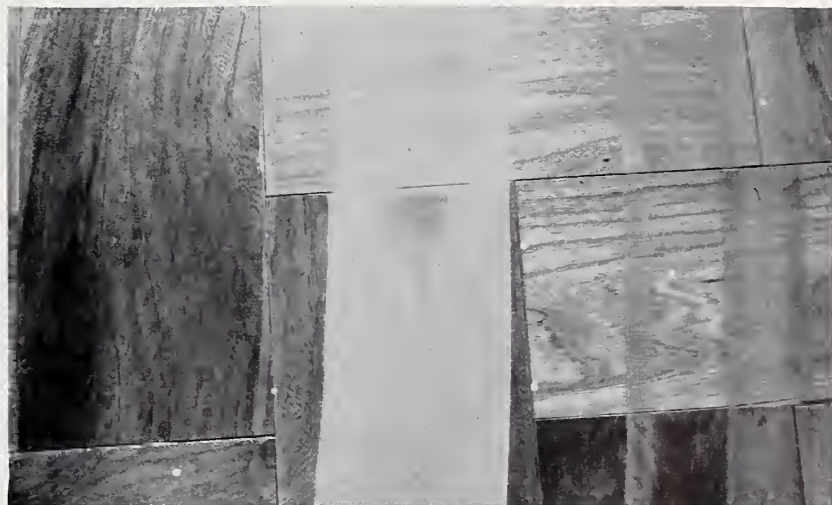
FIGURE 37.— $\frac{1}{2}$ -in. rock-elm plywood tile on concrete subfloor (test panel 17R).

FIGURE 38.— $\frac{3}{8}$ -in. rock-elm plywood tile on fiber mat and strip-wood subfloor (test panel 18R).

The $\frac{1}{2}$ -in. and the $\frac{3}{8}$ -in. Rock-elm plywood tiles, panels 17R and 18R, were in good condition at the end of the test. The tiles were

moderately compressed by the steel-tired truck wheel (see table 1). There was no appreciable fracturing or splintering of the tiles (see figs. 37 and 38). The $\frac{1}{2}$ -in. tile showed better resistance to abrasion than the $\frac{3}{8}$ -in. tile (see table 2). The $\frac{1}{2}$ -in. tiles showed a slight tendency to warp, and they were not in complete contact with the concrete subfloor over the entire area of the test panel. The $\frac{3}{8}$ -in. tiles laid over a $\frac{1}{4}$ -in. rubberized sisal-fiber mat were held together very well by the metal dowel pins but were noisy when walked upon.

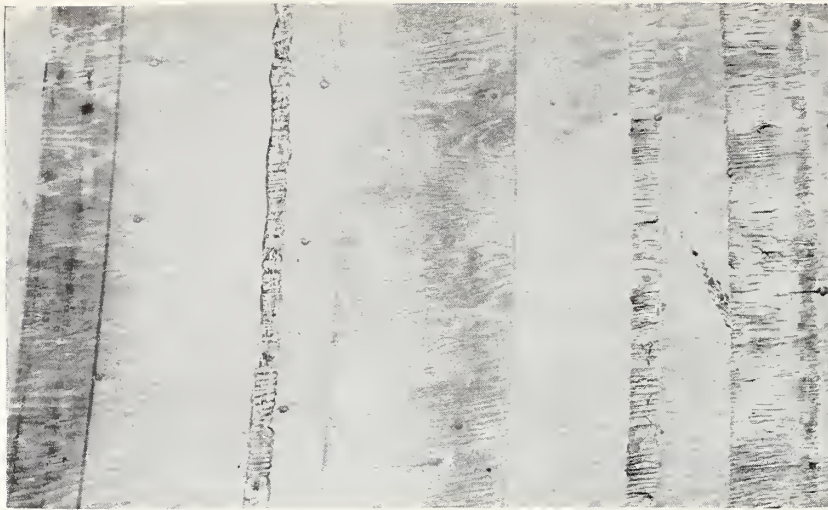
FIGURE 39.— $\frac{1}{2}$ -in. Douglas-fir plywood on strip-wood subfloor (test panel 19L).

The $\frac{1}{2}$ -in. Douglas-fir plywood, panel 19L, remained in fair condition throughout most of the test, although at the end it was in unsatisfactory condition. The plywood was indented and splintered to an appreciable degree by both the steel-tired truck wheel and the steel-wheel easter (see table 1 and fig. 39). The splintered condition did not occur until near the end of the test. The Douglas-fir plywood showed fair resistance to abrasion (see table 2).

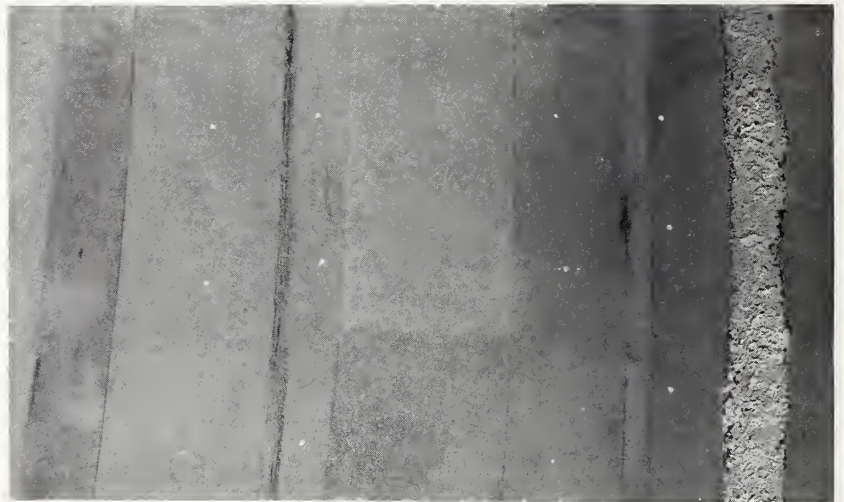
FIGURE 40.— $\frac{1}{2}$ -in. magnesium-oxychloride composition on strip-wood subfloor (test panel 19R).

The $\frac{1}{2}$ -in. magnesium-oxychloride composition floor reinforced with expanded metal, panel 19R, did not show satisfactory performance on a strip-wood subfloor. The floor was pitted and worn appreciably by the steel-tired truck wheel (see table 1 and fig. 40). A fine crack developed in the floor along the entire path of the walking wheel (see fig. 40). The floor showed only fair resistance to abrasion (see table 2).

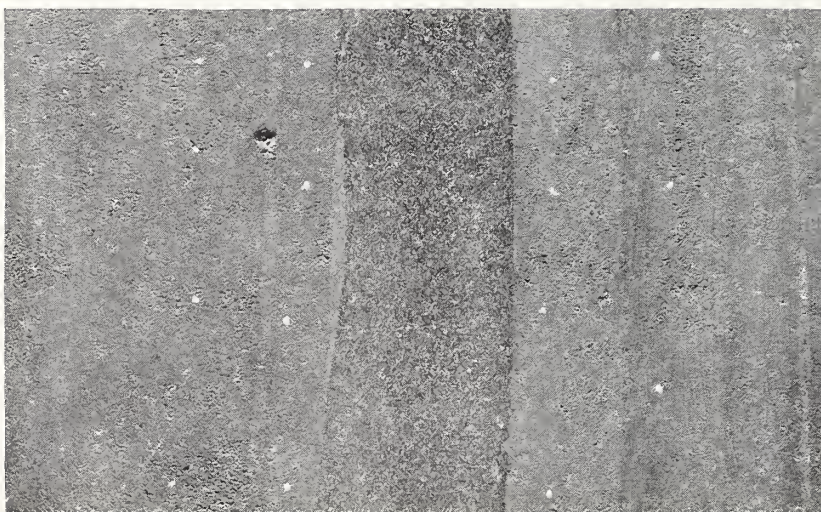
FIGURE 41.— $\frac{1}{2}$ -in. alumina cement-latex composition on concrete subfloor (test panel 20R).

The $\frac{1}{2}$ -in. alumina cement-latex composition floor, panel 20R, showed unsatisfactory performance. The surface was depressed appreciably by the steel-tired truck wheel and was also depressed to a moderate degree by the rubber-tired truck wheel and the leather-shod walking wheel (see table 1 and fig. 41). There was no evidence of fracture in the floor and bond to the concrete subfloor was excellent. The floor

was worn to an appreciable degree by the abrasive action of the walking wheel (see table 2).

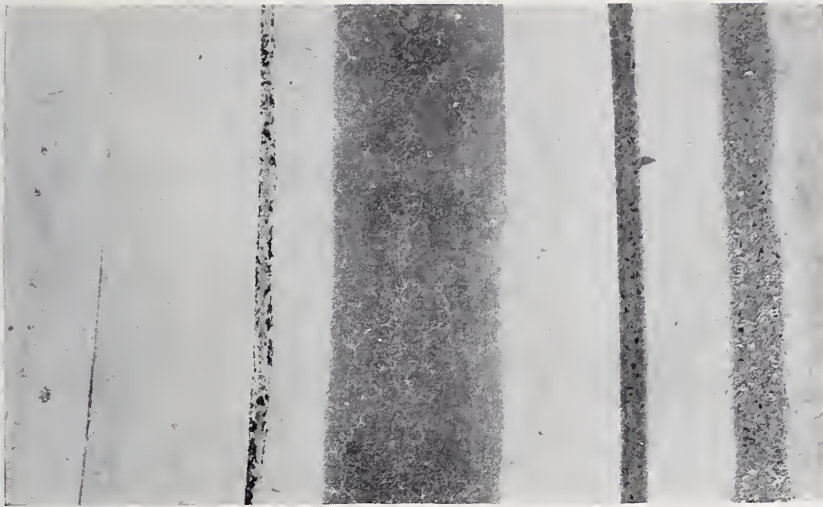
FIGURE 42.—1-in. cement-mortar topping, 1:2 mix, on concrete subfloor (test panel 20L).

The 1-in. cement-mortar topping, panel 20L, showed good performance. The topping was pitted and worn to a slight degree by the steel-tired truck wheel (see table 1 and fig. 42). The fine cracks showing along the path of the walking wheel are due to internal shrinkage of the topping. The topping showed fair resistance to abrasion (see table 2).
